RE: **Baruch College - Site "B"**
Contract #16 - GC #2
Epoxy Terrazzo - Uplift/Debonding

PRELIMINARY SITE INVESTIGATION REPORT

Client:	TDX Construction Corp.	Lab #:	Pending
Project:	Baruch College - Site B	Report #:	ML-01
Address:	55 Lexington Avenue New York, New York	Field Visit Date:	03/04/03
Construction Type:	Terrazzo flooring system on concrete slab	Report Date:	03/05/03
		Petrographer:	J. Walsh
		Page 1 of 10

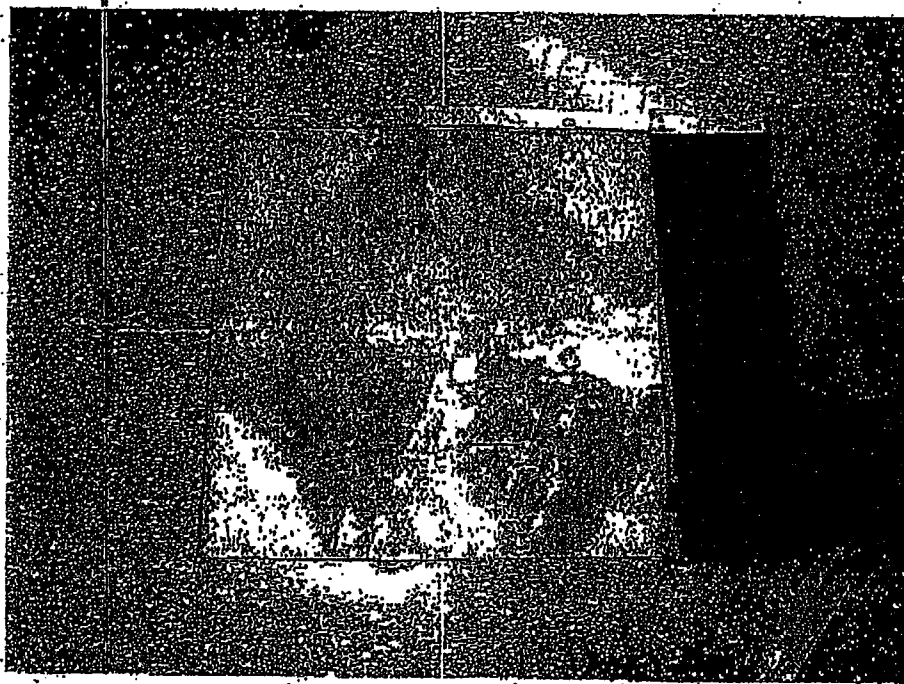
- 8) Probe 2W exposes a section centered on a corner of four terrazzo segments. The original debonding (as opposed to that created by the sample removal) is clearly defined as a rounded cross. This indicates a regular ovate pattern of failure.

Figure 2: Probe location 2W. The location intersects the corners of four terrazzo segments. The dark rounded cross reflects where the epoxy debonded cleanly from the substrate. The lighter areas reflect "rip-ups" during sampling. The debonding pattern is consistent with that related to shrinkage.

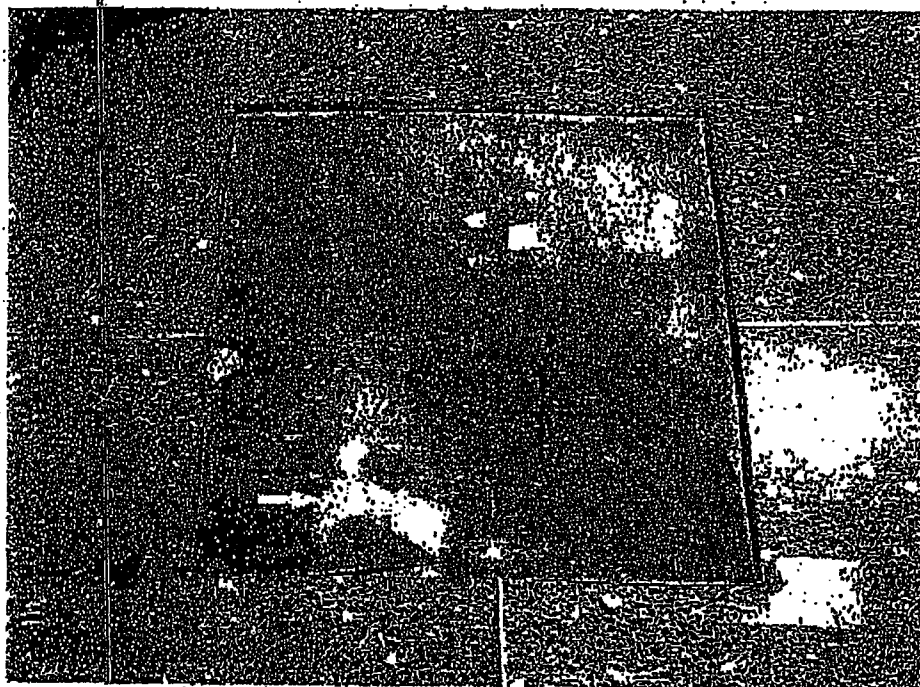
- 11) Some indication of failure between the slab and self-leveling flooring bond is noted. This is evidenced by clean separations at probe locations 7 and 12. Probe B-1 exposes a four corner contact. Sounding of the substrate revealed a debonding of the Conflow only below one corner of the four terrazzo segments. Samples of the debonded Conflow were recovered freshly from the substrate.

Figure 5: Probe location B1. The epoxy membrane is completely debonded from the smooth self-leveling compound surface. In the lower left quadrant (arrow), the self-leveling compound is clearly debonded from the concrete substrate. Sounding indicates that the debonding is present nearly everywhere below that one corner.
